### Case Riohacha

#### Unit condition analysis SK440 (Gas engine-compressor kit)

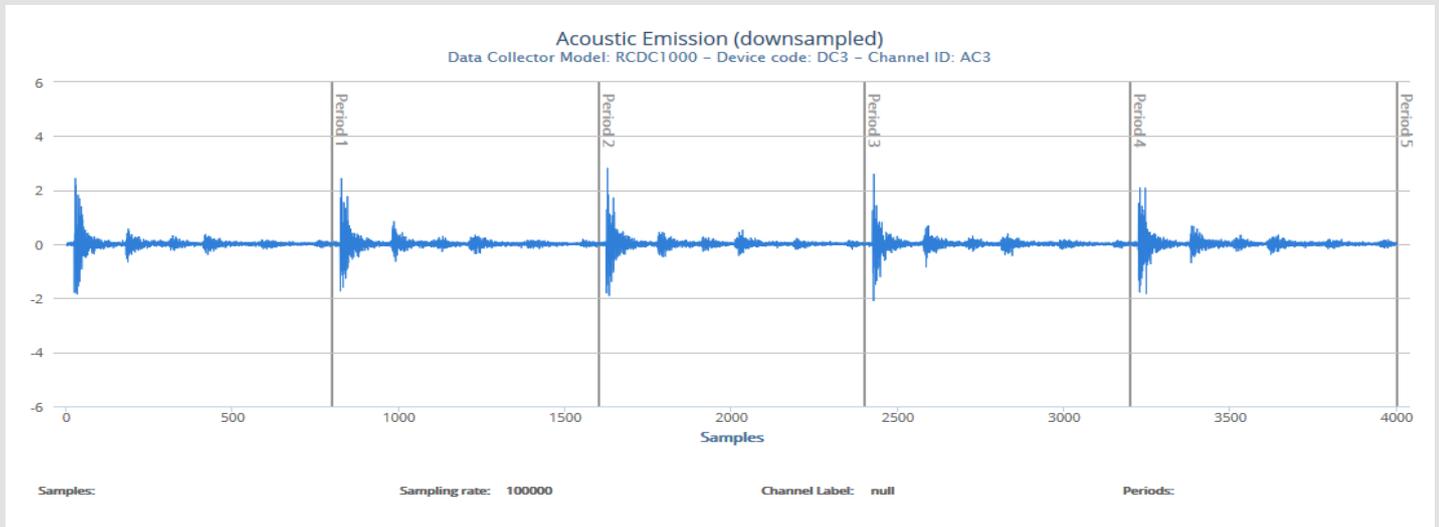
For comparison purposes, Holiztech record of the HE3 valve is sent together to a report to show that no anomaly was detected in online monitoring unlike that reported by the contractors. The amplitude values in HE3 have remained stable and have not activated any of Holiztech alerts. In the lower part of the document the valves can be seen to be dismantled later during a scheduled maintenance for the 2000 hours of service. It can also be seen that they are in suitable conditions to continue operating and there are no signs of wear or damaged parts.

*Raw data taken from the HE3 valve of the compressor. No anomalies are found*

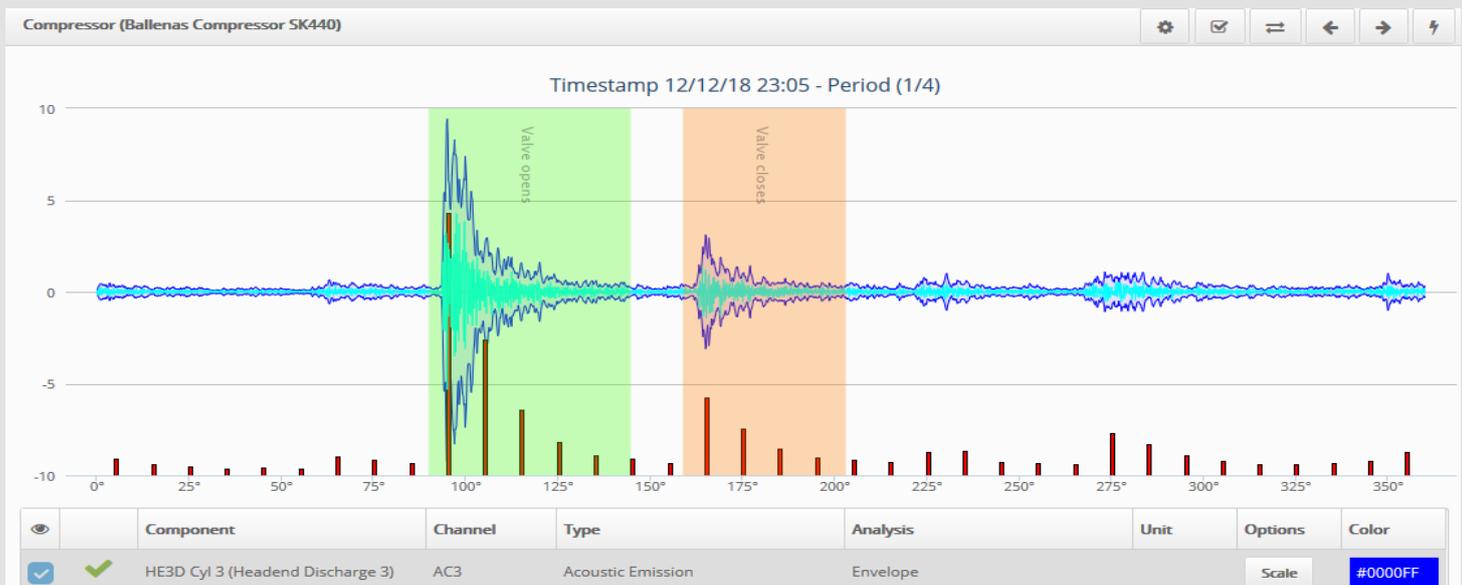
*Valve ultrasound analysis on HE3*

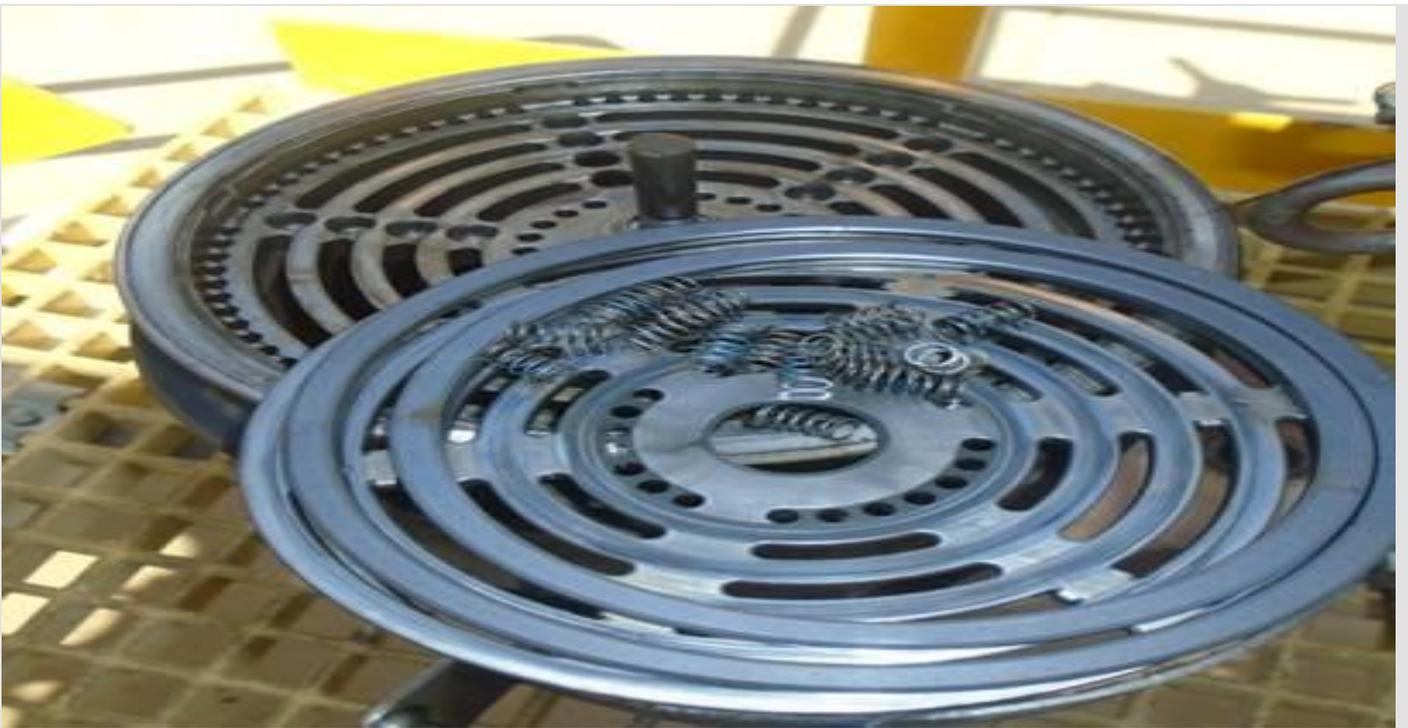
*Valve removed during scheduled maintenance*

Work Order WO7052775 was issued by the contractor based on their analysis. This consisted in the revision of the valves that had been indicated with problems and their replacements if necessary. The execution of this task required investing time and resources in removing the covers, dismantling the valves and carrying out the respective tests (sealing and checking wear) to validate the need of changing them. This entire process represents, between production losses and labor costs, around 19,700USD. All this money was saved thanks to the verification carried out by the Proximotec's engineers through the Holztech monitoring system installed in said gas pumping unit.

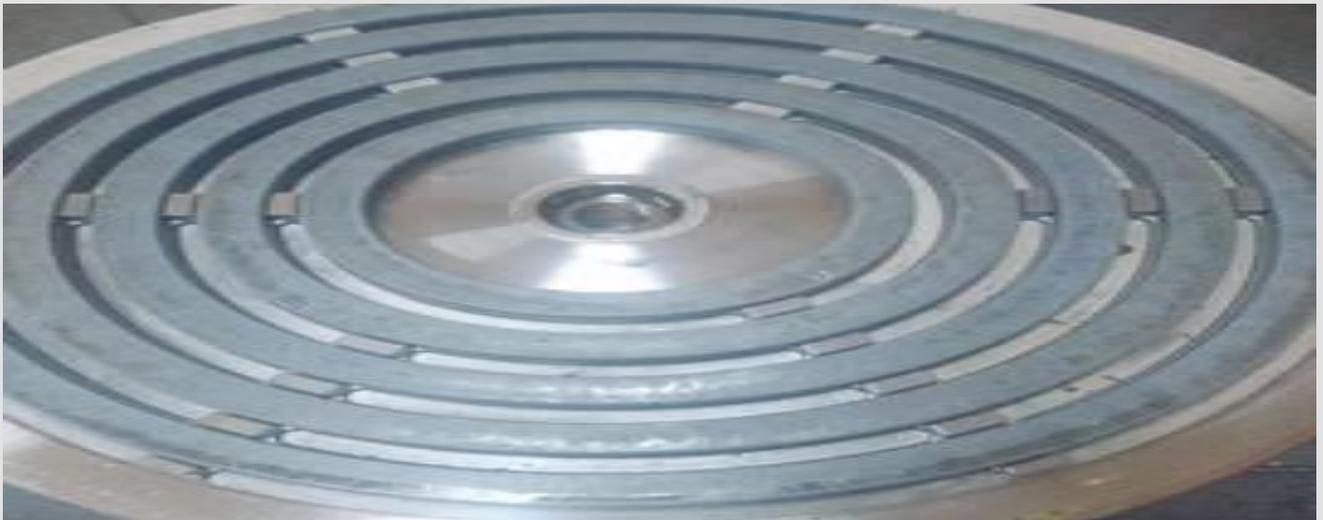
*Visual inspection of the valve. Elements in good condition.*
